**Evaluation of DOE Report:
Annual Report in Support of Compliance Plan No. CP-50284-000, April 1, 2005**

**Effectiveness of the Perched Aquifer Pump and Treat System
December 2005**

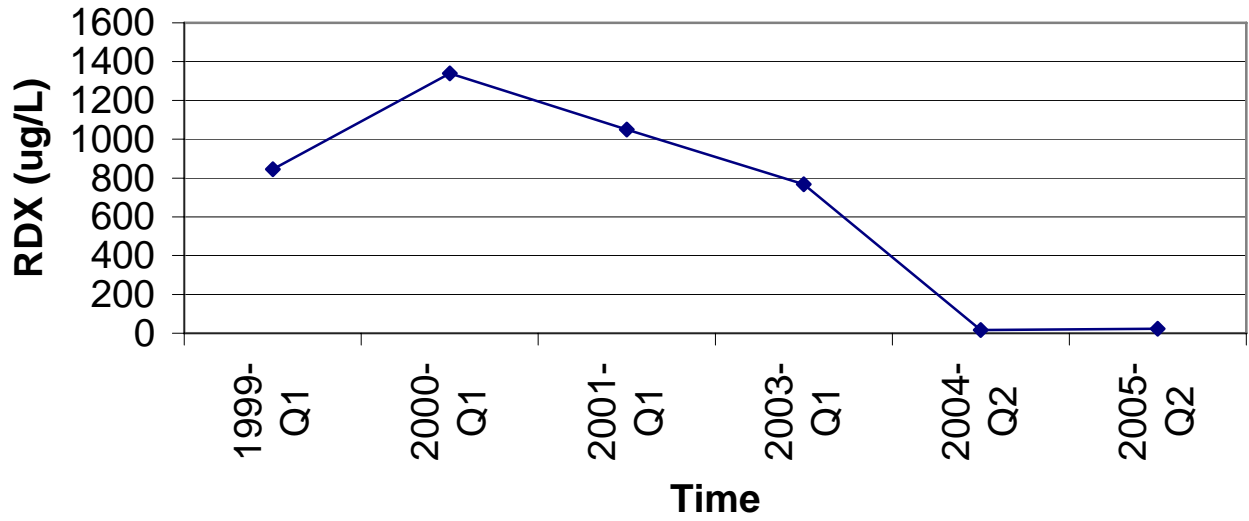
Figure 1

To date, cleanup appears to have been effective in only one of the selected wells: PTX06-1005 (figure 1). Between 1999 and 2005, RDX concentrations dropped from approximately 1000 µg/L to 20 µg/L. This is less than the TCEQ Industrial Risk Reduction Standard 2 level of 26 µg/L³. However it is higher than the EPA lifetime health advisory of 2 µg/L⁴. Well PTX06-1005 is near a clean-up system injection well⁵. This may be the reason RDX concentrations have decreased as much as they have.

RDX, PTX06-1005

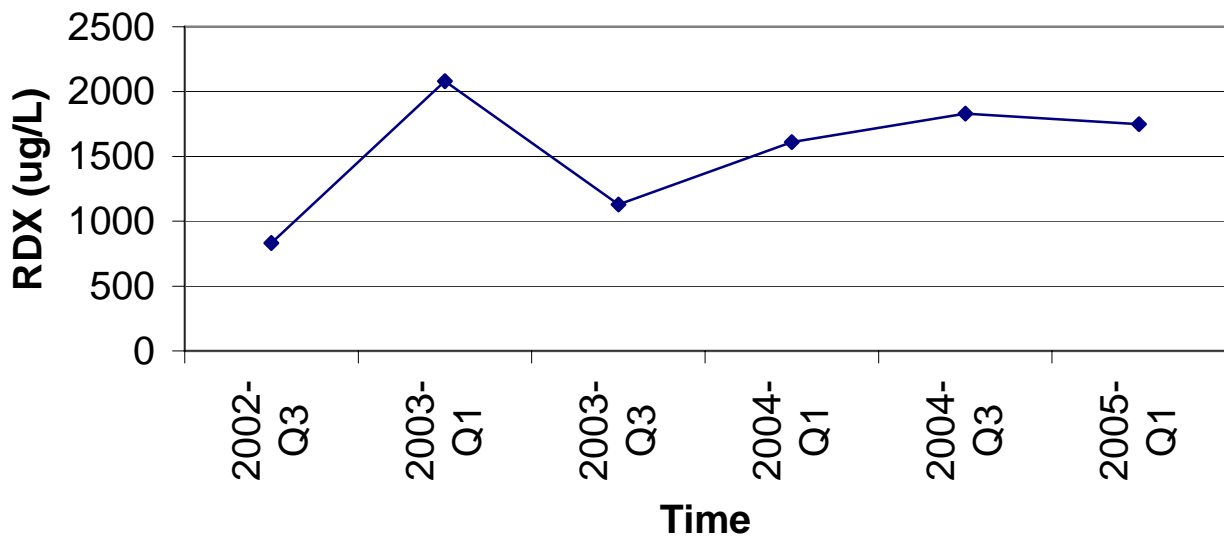
Figure 2

RDX, PTX06-1030

RDX concentrations have declined in some wells (e.g., PTX06-1042, figure 4) and increased in others (e.g., PTX06-1046, figure 5). Still, except for well PTX06-1005, RDX concentrations remain high in all the wells (figures 2 – 7), far above any standards established to protect human health.
